NASA Technical Paper 1042

Light Airplane Crash Tests at Impact Velocities of 13 and 27 m/sec

Emilio Alfaro-Bou and Victor L. Vaughan, Jr.

NOVEMBER 1977

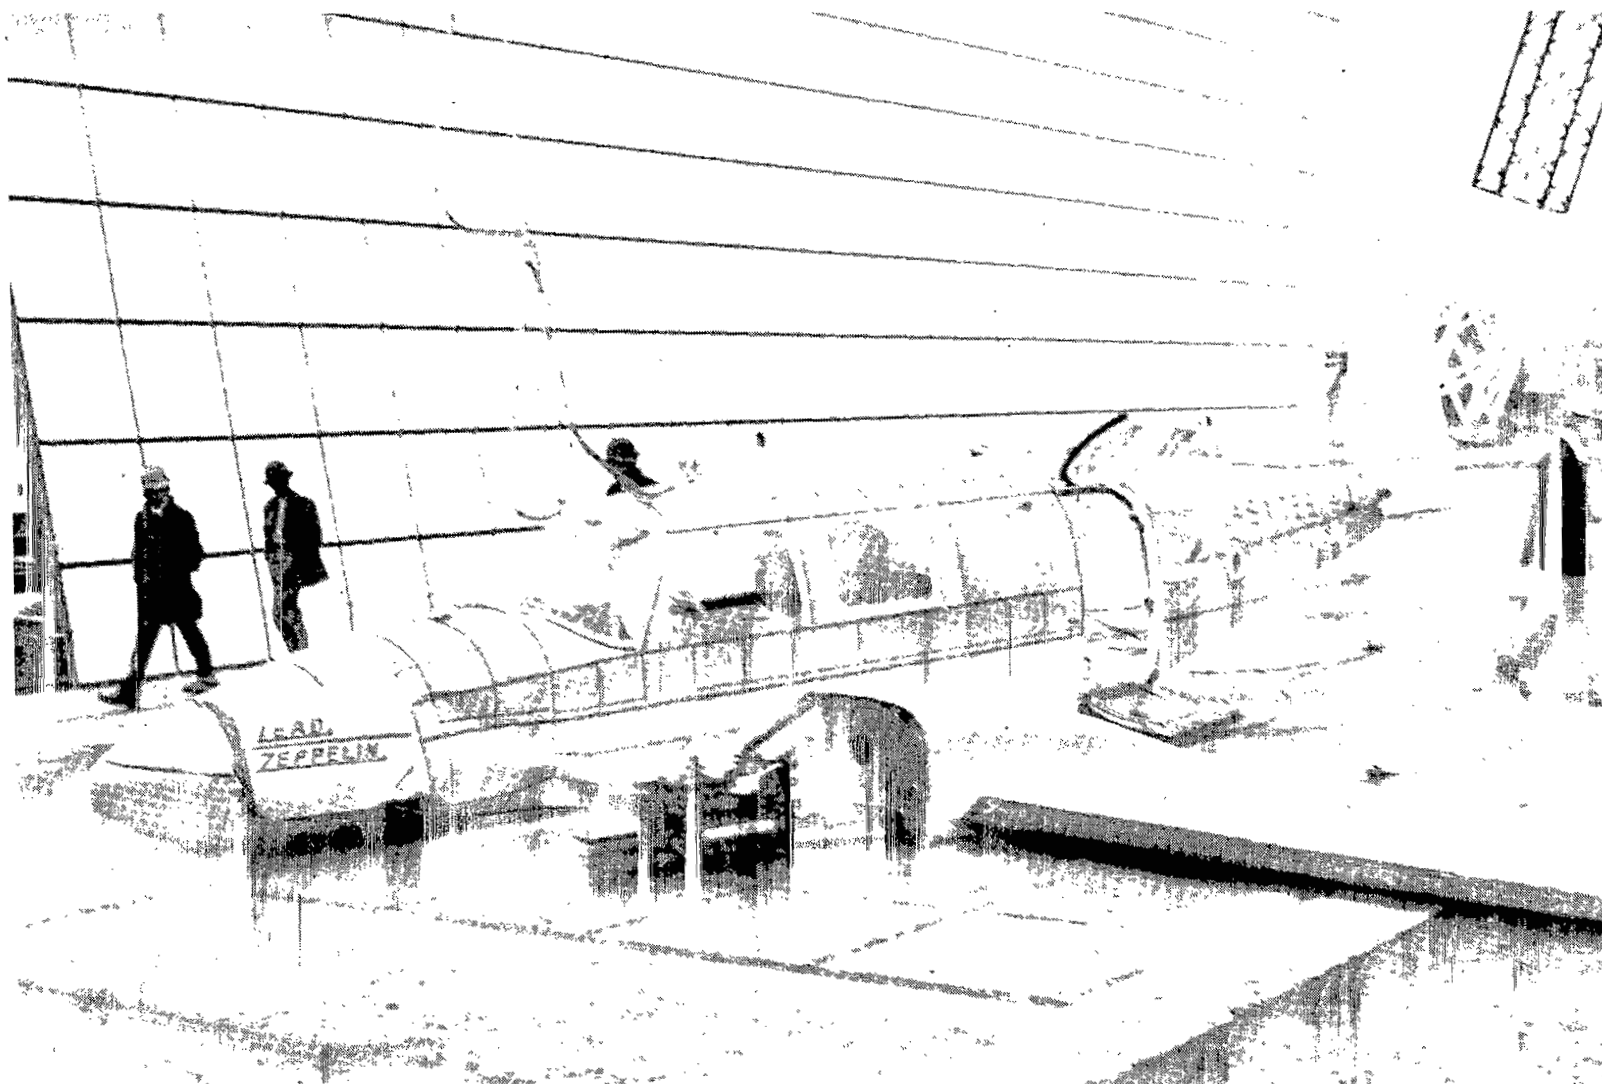
L-74-1579

Photographs showing external damage to the specimens for tests 1 and 2 are shown in figures 10 and 11, respectively. The damage to the nose area of the specimen was approximately the same for both tests. (See figs. 10(a) and 11(a).) The crash forces in the nose area were more intense and the damage more severe than in other parts of the specimen. However, the damage was restricted to the cowling and fire wall where most of the impact energy was absorbed by crushing of the structure during nose contact. Some of the remaining energy in the form of small attenuated forces and motions was transmitted to the cabin area.

(a) Overall damage.

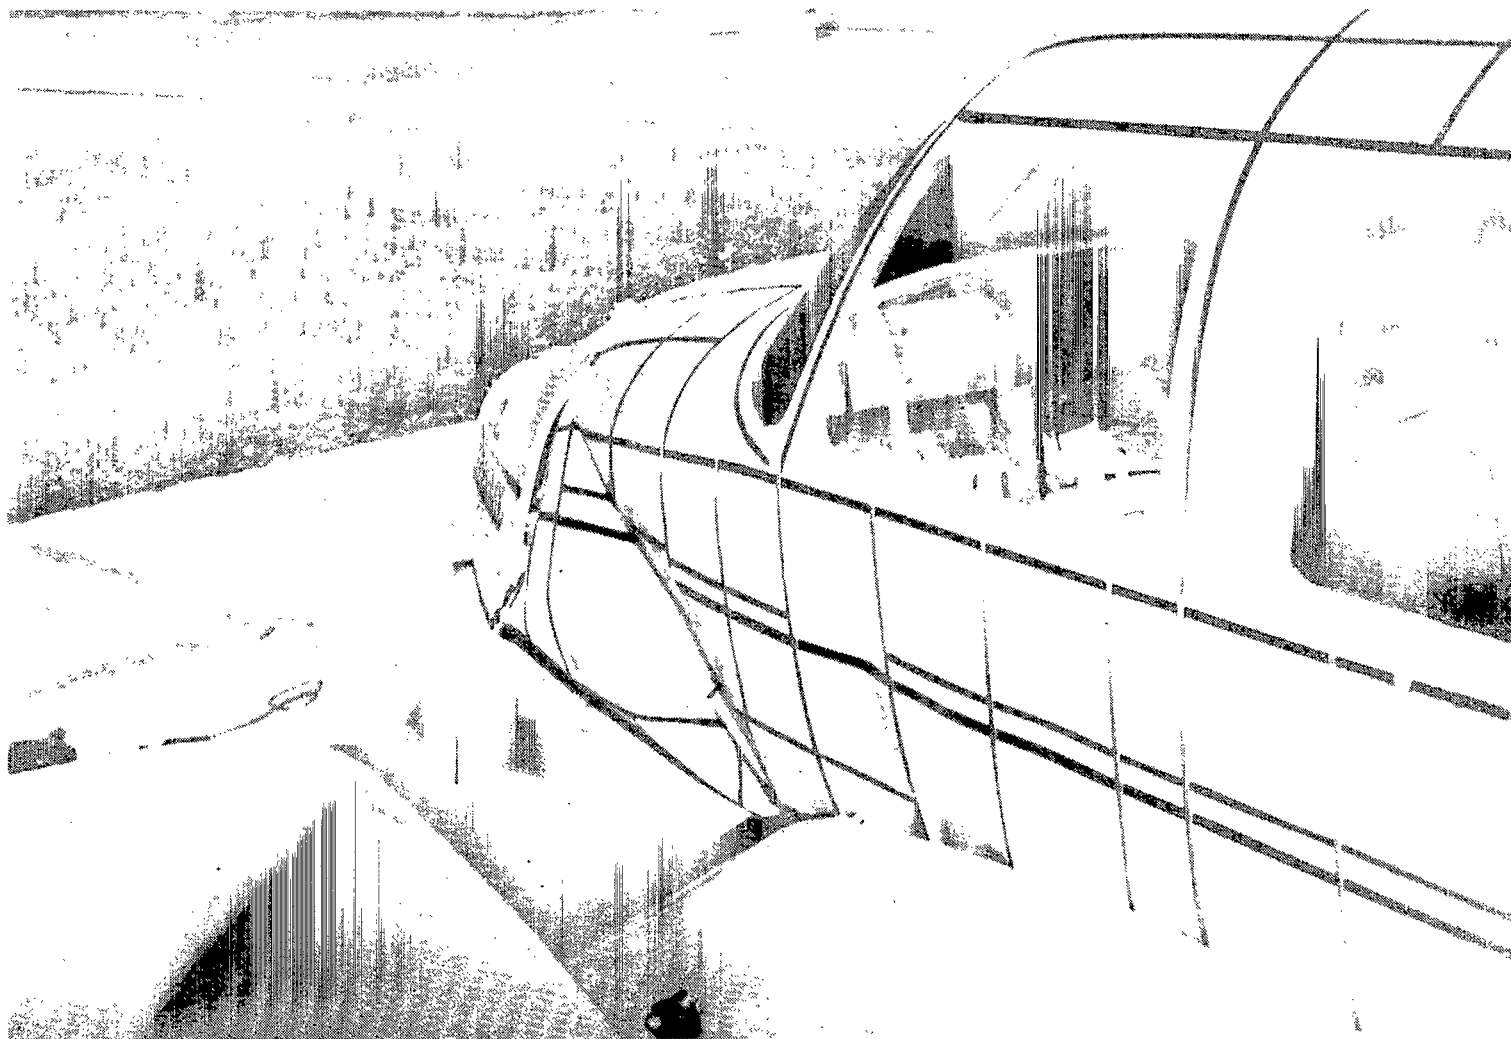
L-74-724

(b) Closeup of nose damage.

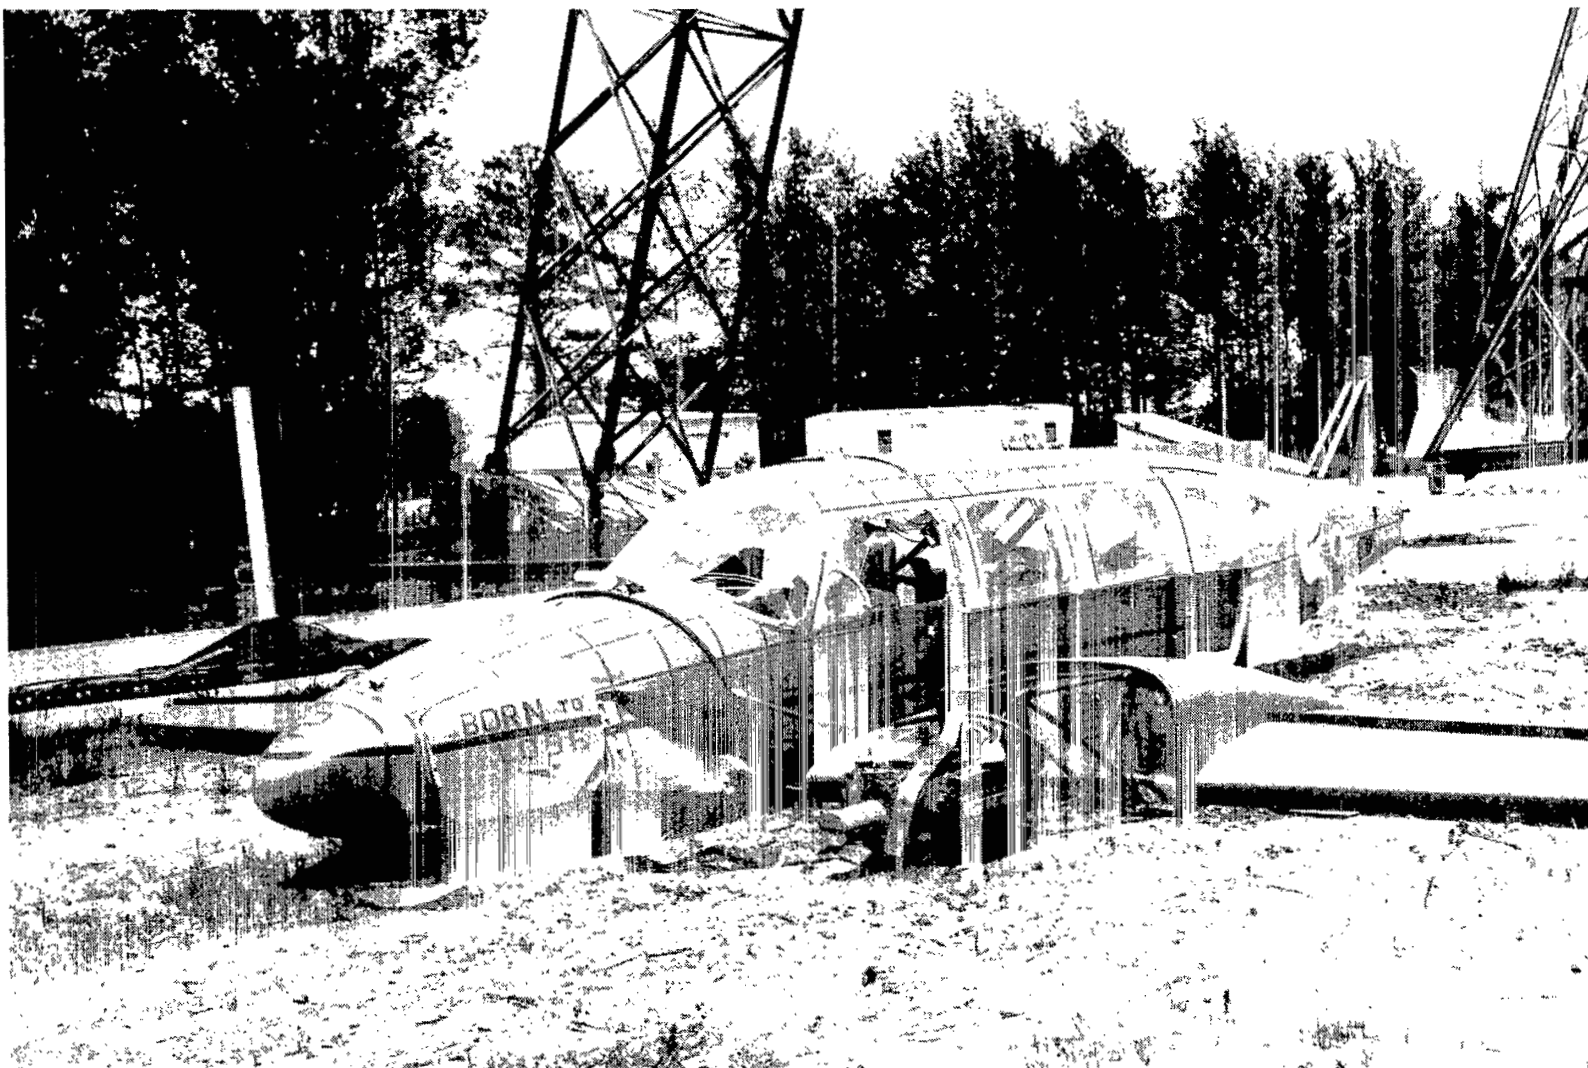
L-74-2629

In test 2 the skin wrinkled from nose to tail on both sides of the fuselage. The overlapping sheet metal on top of the fuselage separated along the rivet line behind the first window due to rivet shear. Similar breaks occurred along the rivet line at the base of the windows. (See figs. 11(a) and 11(b).) The separation along the rivet line on top and along the side of the fuselage occurred during second impact when the roof continued to move downward as the floor was brought to rest and this movement caused a lateral expansion of the cabin.

(a) Overall exterior damage.

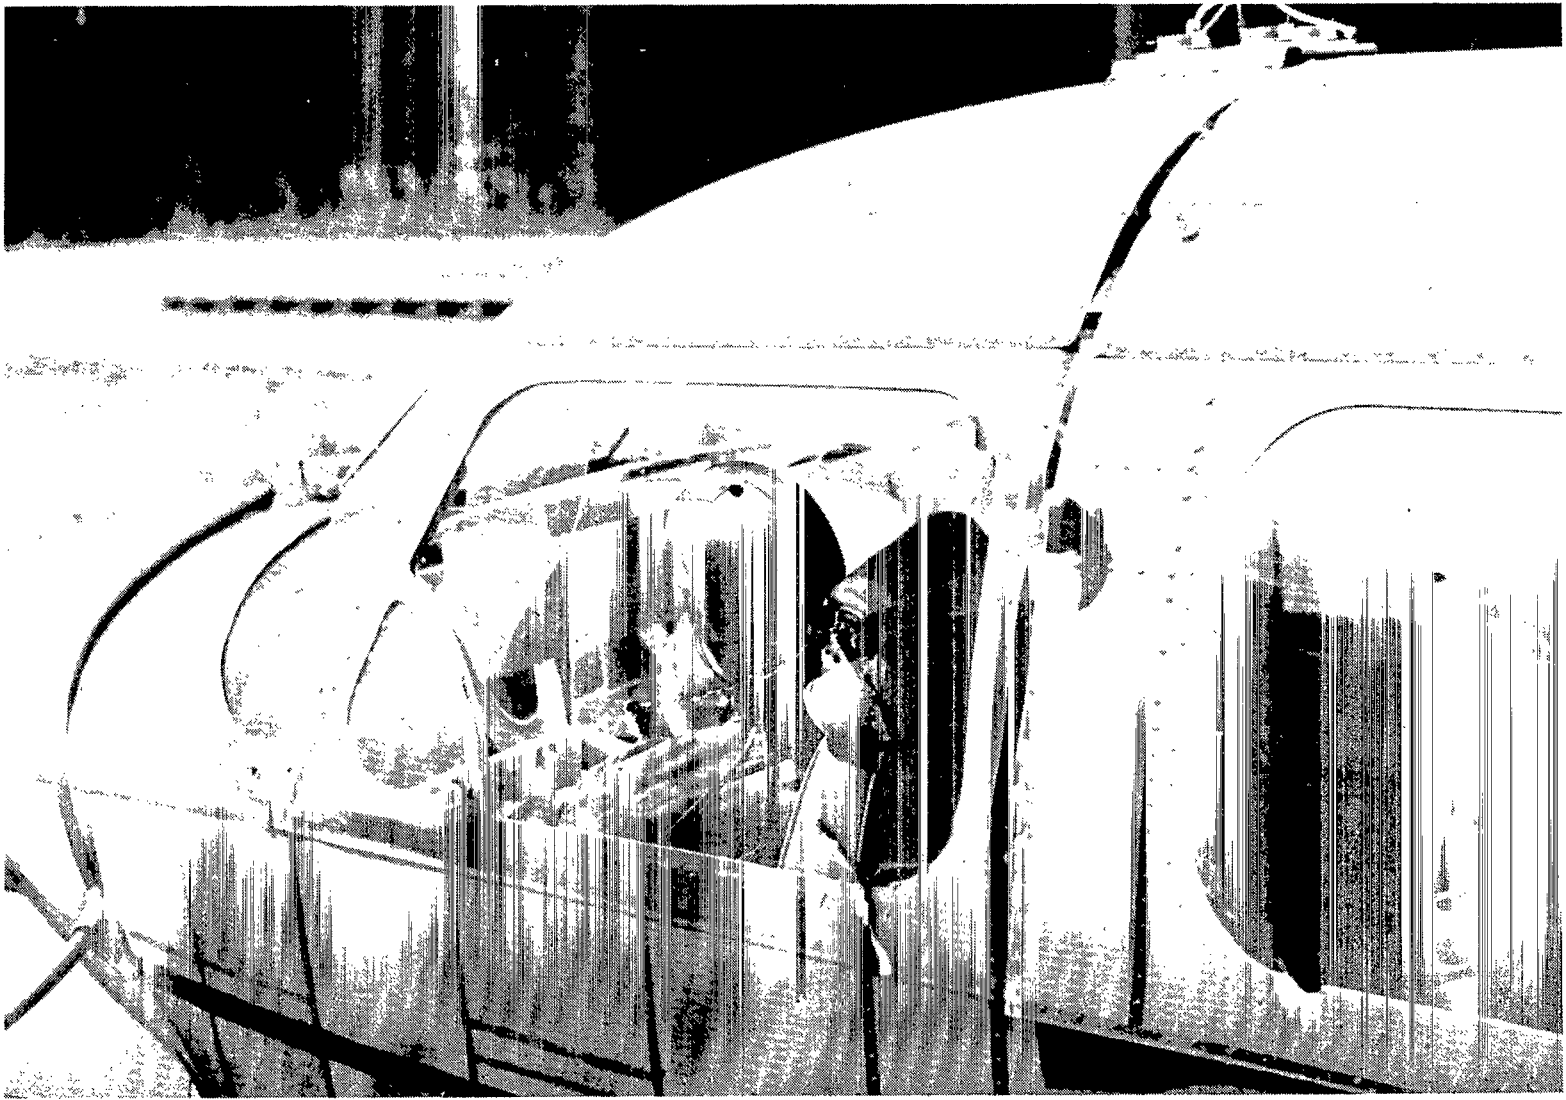
L-74-2632

(b) Sheet metal separation along rivet lines.
